Thermal Inspection :

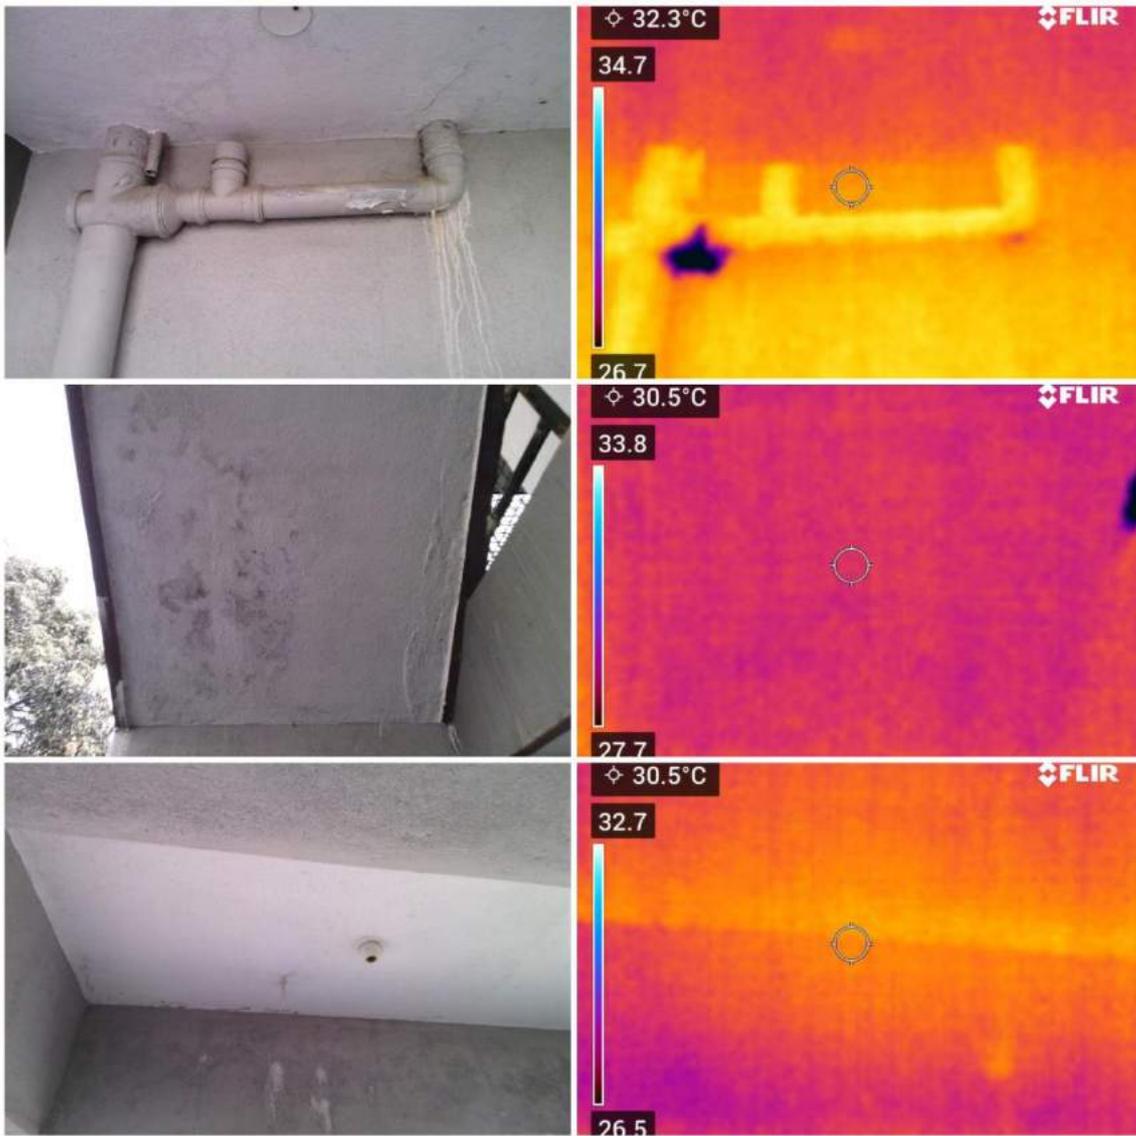
3 . The vacant house in the floor 2 is thermal scanned found dampness in the corner and the window side on tracking it is confirmed coming from out side the cracks and from the upper side bathroom , we scanned the bathroom also due to un use dampness not found , but the joints gap is seen in the floor where the grout is fully chip off before using the bathroom epoxy must done .

- 3 . Both the building terrace along with the parapet wall must be waterproof done to avoid the water leakage with crack filling apply of two coat .
- 4 . For the top floor house and the vacant house bathroom epoxy grout to be done , it is better to see other bathrooms in building if nesserly that also be epoxy done .

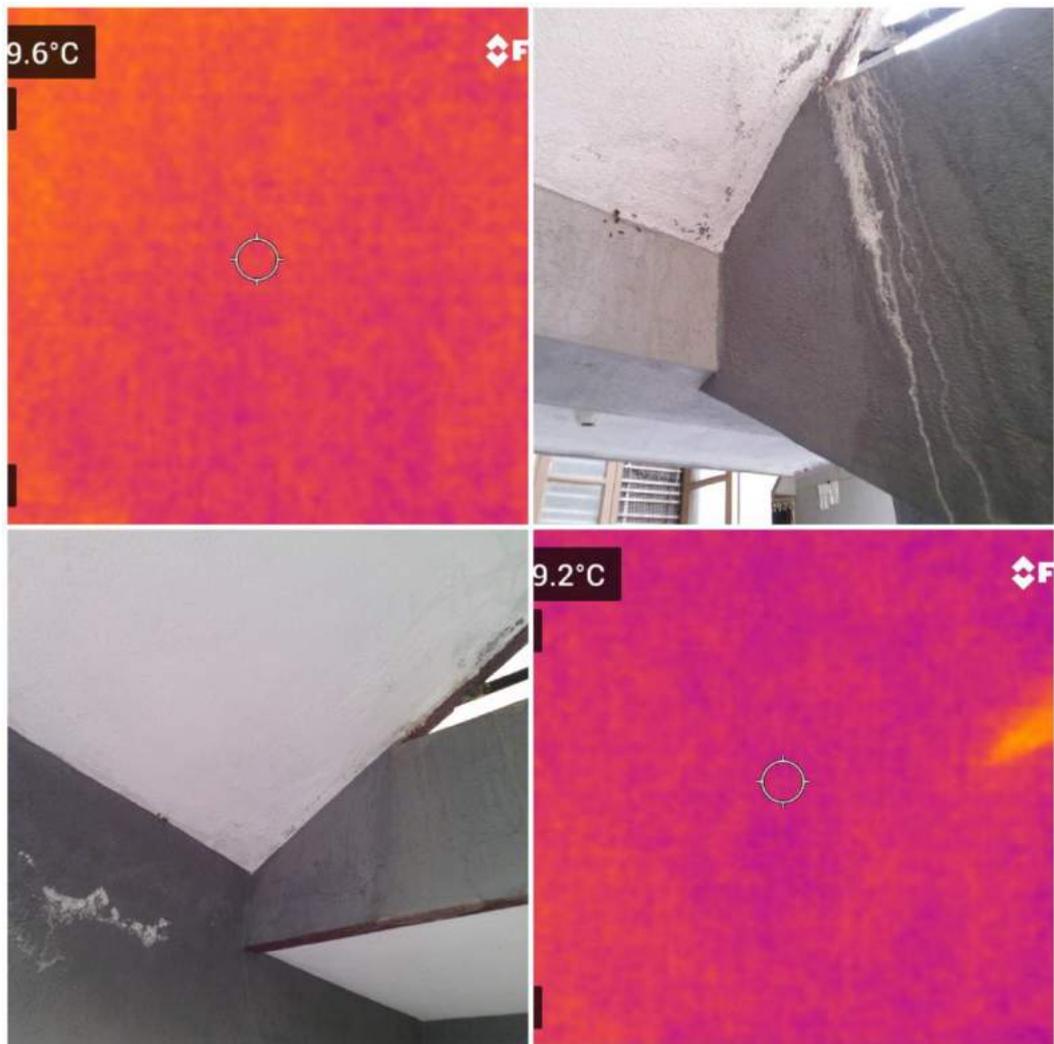
4 . Leakage dry is seen in the junction of the sanitary pipe it is stopped because it is not using if it use leakage will start this can be avoid by making epoxy grout to the vacant home bathroom , on scanning the thermal photos the walk area granite joints gaps are found in this while daily washing the water will flow through this gap forming dampness in stair case and mesh drop , Even in the mesh droop in all flooring will have white patches form and cracks in the rainy seassion it increases

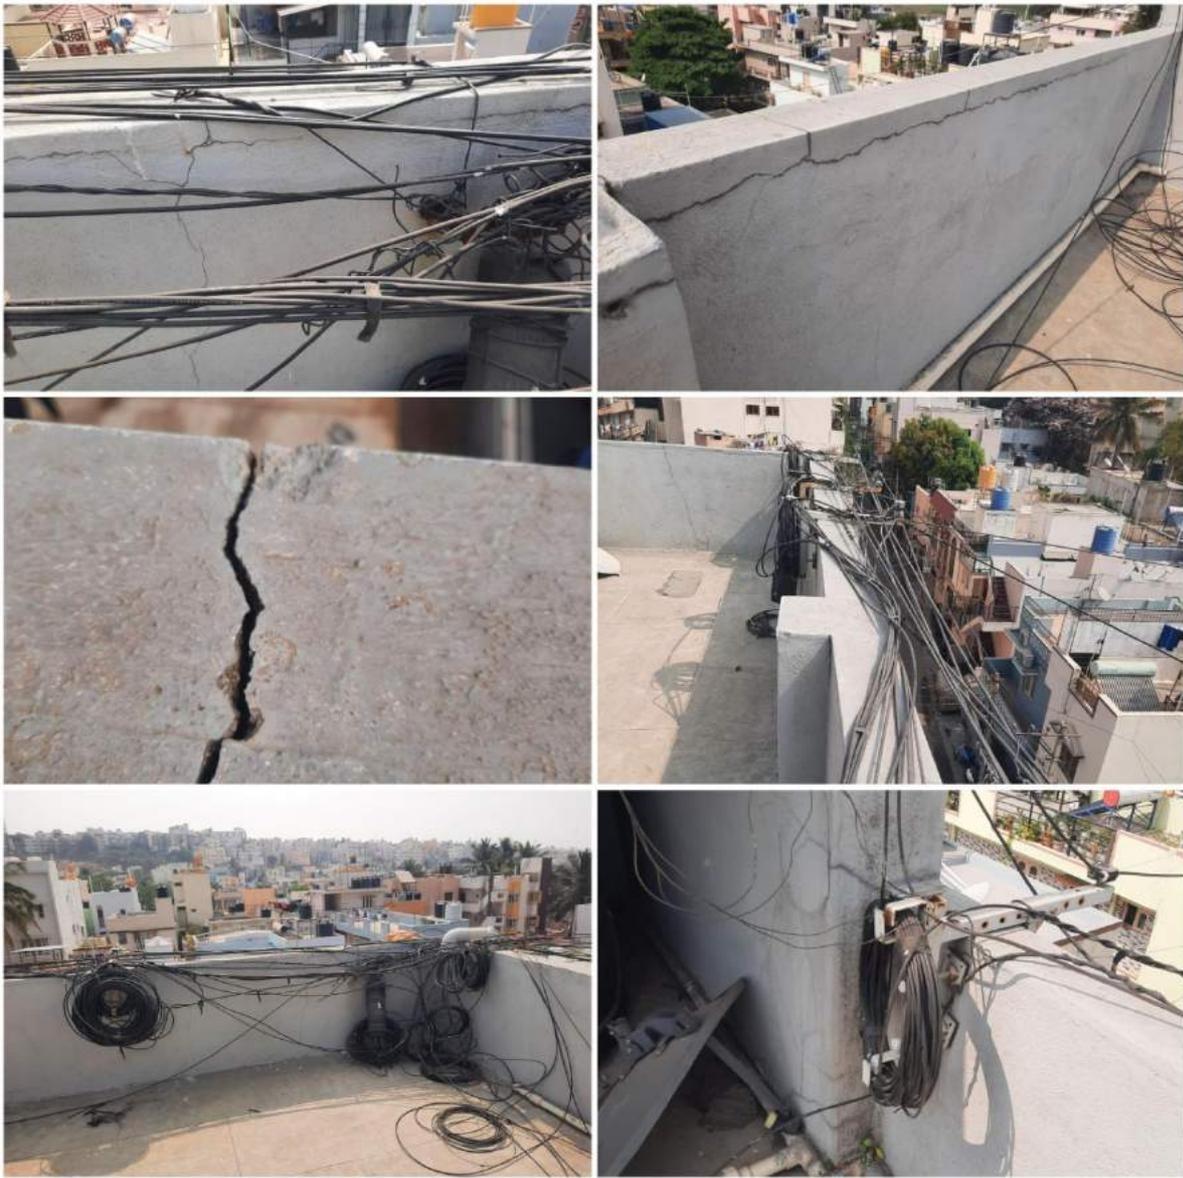
6. Dampness found in next building at 1st floor leaving hall area on thermal scanning, the dampness causing from upper parapet wall the neighbour building toilet is attached to your parapet wall and another side crack in the corner of parapet wall at the mould level in the other neighbour mould area , this are the source for the dampness .

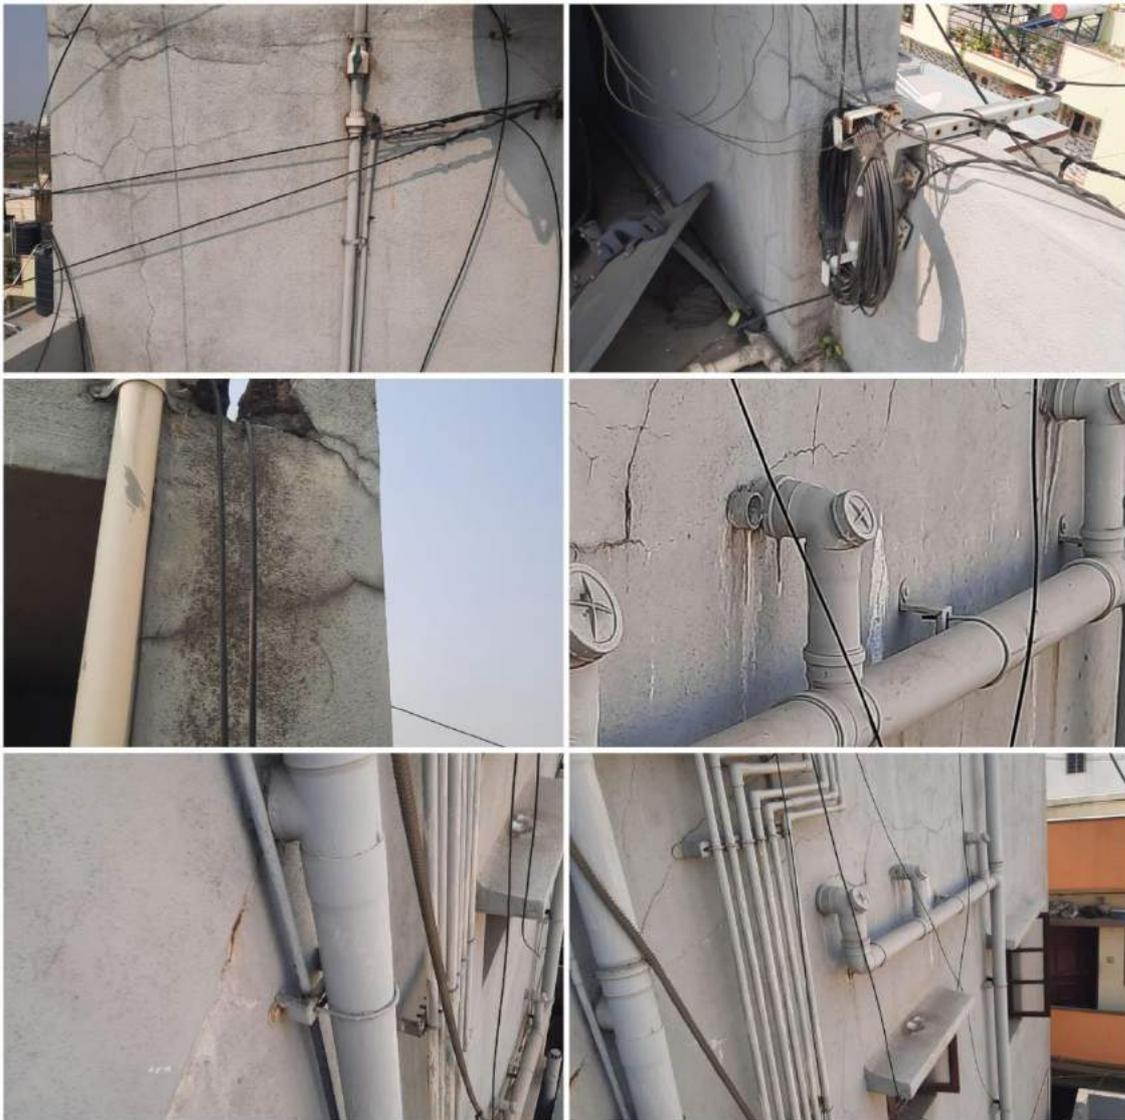
7. In the terrace lot of cable wire is seen in para pet wall with the many angle fixed on the walls this are the reason for the cracks in the parapet wall due to the weight and the stretchable force , it must shift immediately in rainy seassion rain water will flow through the crack forming the dampness .

- 1 . We inspect the building by physically and taken the thermal scanning photos on tracking the thermal photos following solutions are given .
- 2 . Remove or replace the cable wire from the parapet wall , crack filler must fill in to the cracks and holes form in the parapet walls , Dr Fix crack filler is suggested .

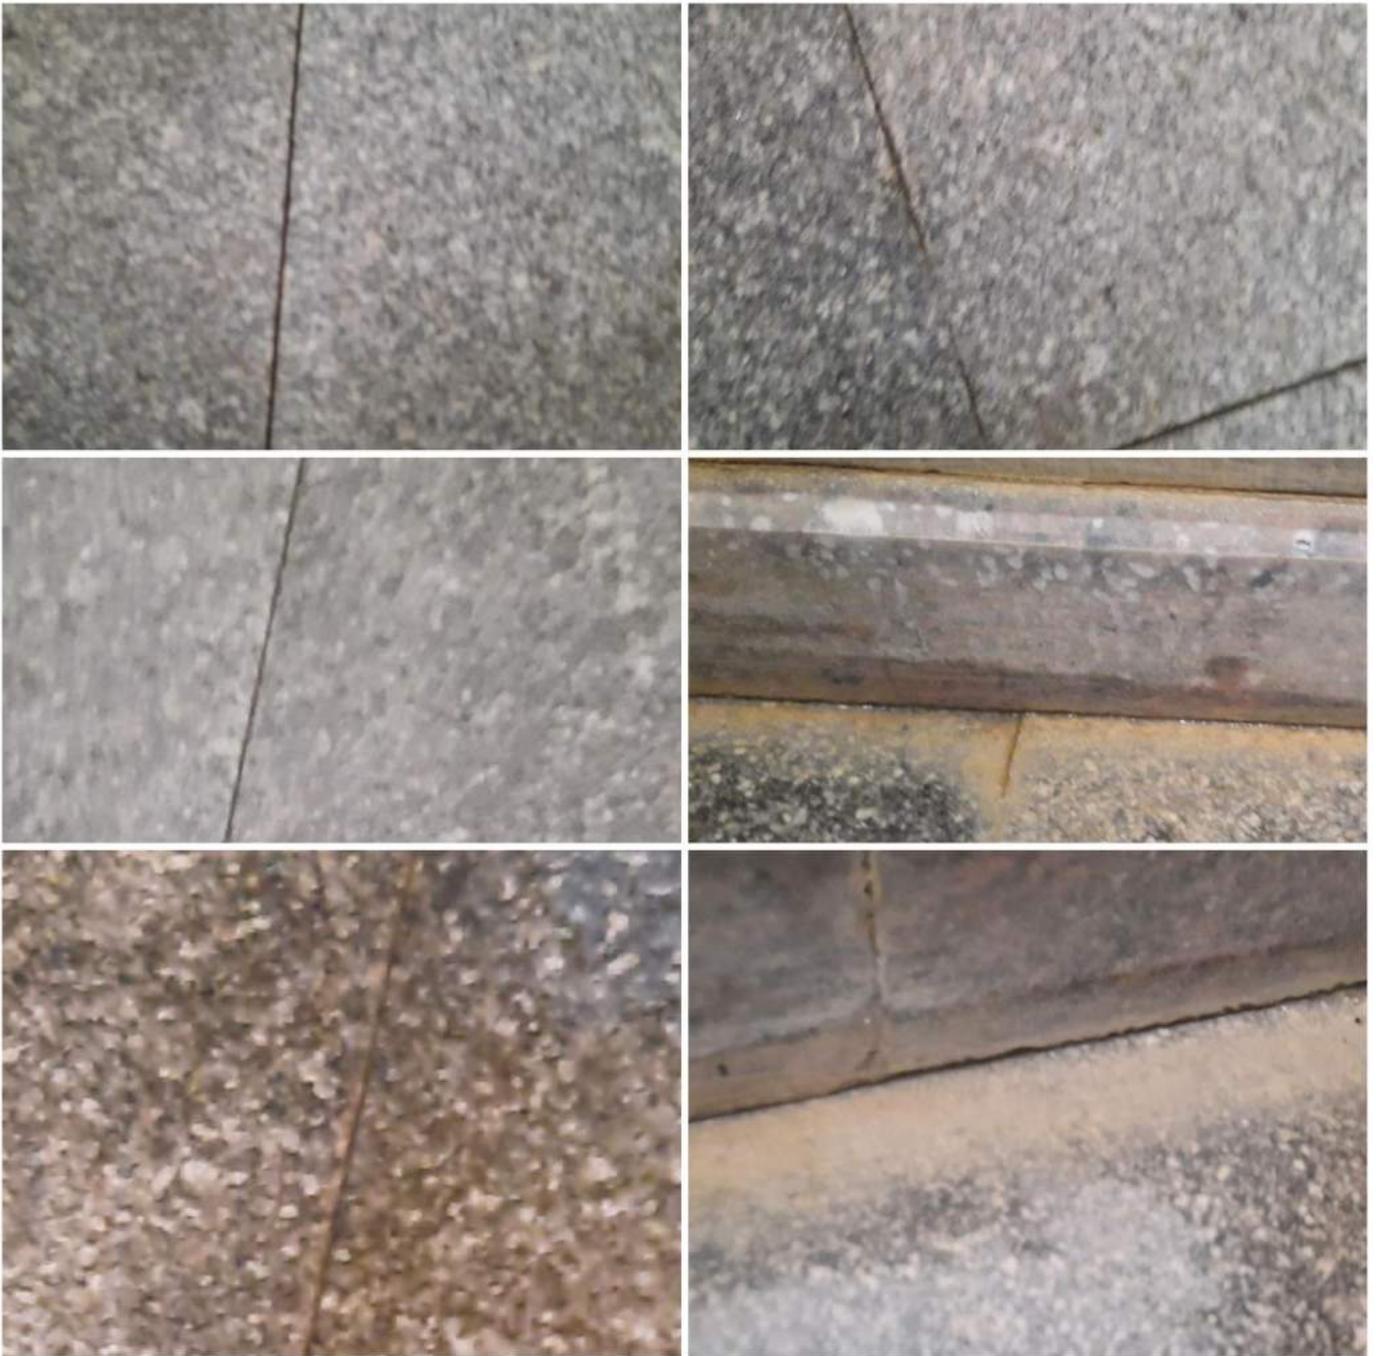
8. Cracks is seen over all building some due to the cable pruser and other are joint cracks or irregular of core packing , while the plumbing line work while making holes the sound impact form the air crack which later become increasing .

- 5 . In the staircase and the walking area joints to be cover by the epoxy to avoid the water leakages .
- 6 . Over all building fill the crack filler and then paint Dr fix rain coat paint is suggested 2 coat it will be the protective layer or the Tuilase paints
