Thermal Inspection :

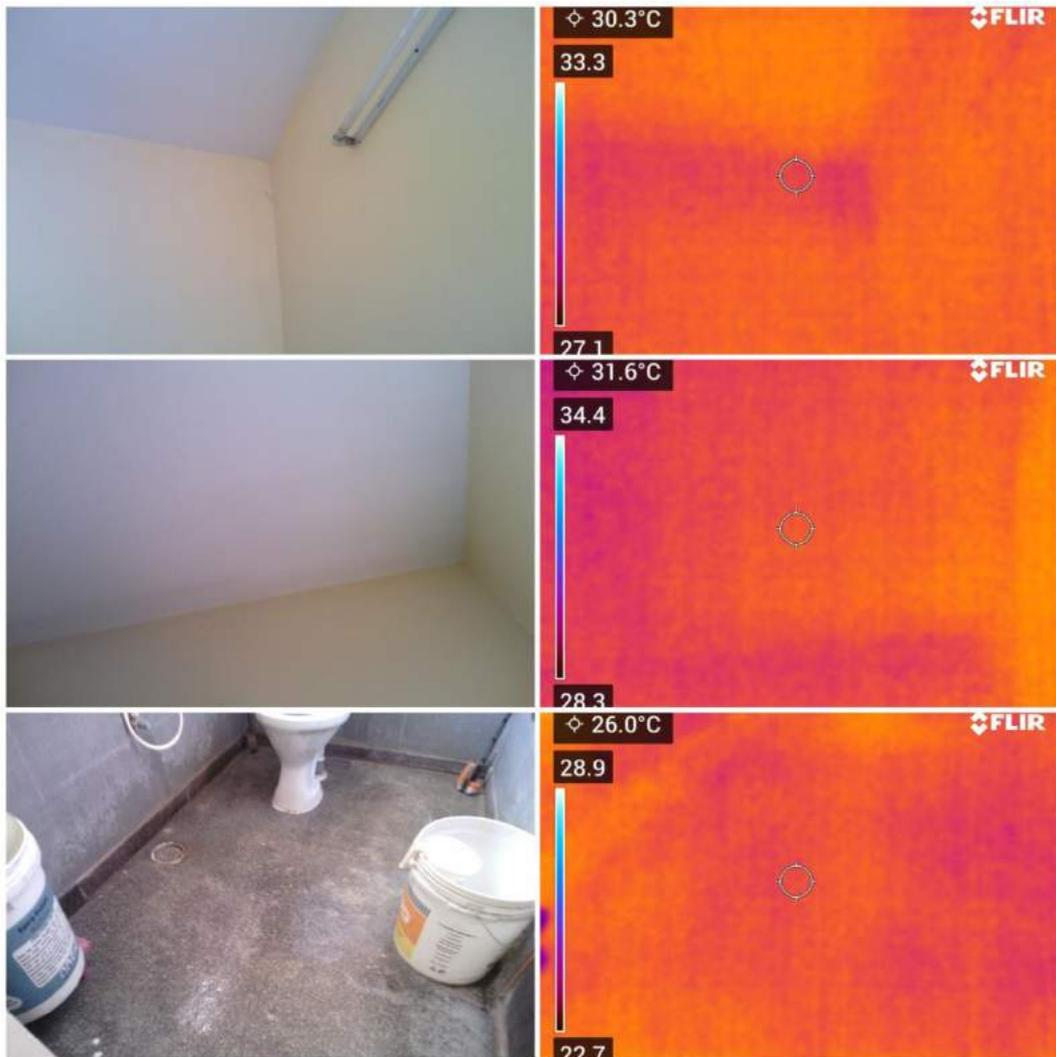
1. Slightly dampness found in the corner and the side wall in the top floor room. On tracking the thermal scanning photo, it is coming from the above mould area where the water tank is placed. There are also so many cracks seen; the water will flow in the cracks from the dampness in the wall. In the bathroom of the same room, dampness was found on thermal scanning. This is due to the gaps between the slab grout as they have been chipped off. Water will flow in the gaps, forming the dampness.

- 3 . Both the building terrace along with the parapet wall must be waterproof done to avoid the water leakage with crack filling apply of two coat .
- 4 . For the top floor house and the vacant house bathroom epoxy grout to be done , it is better to see other bathrooms in building if nesserly that also be epoxy done .
